04 OCT 10 (sun)  
FROM PH2804-1

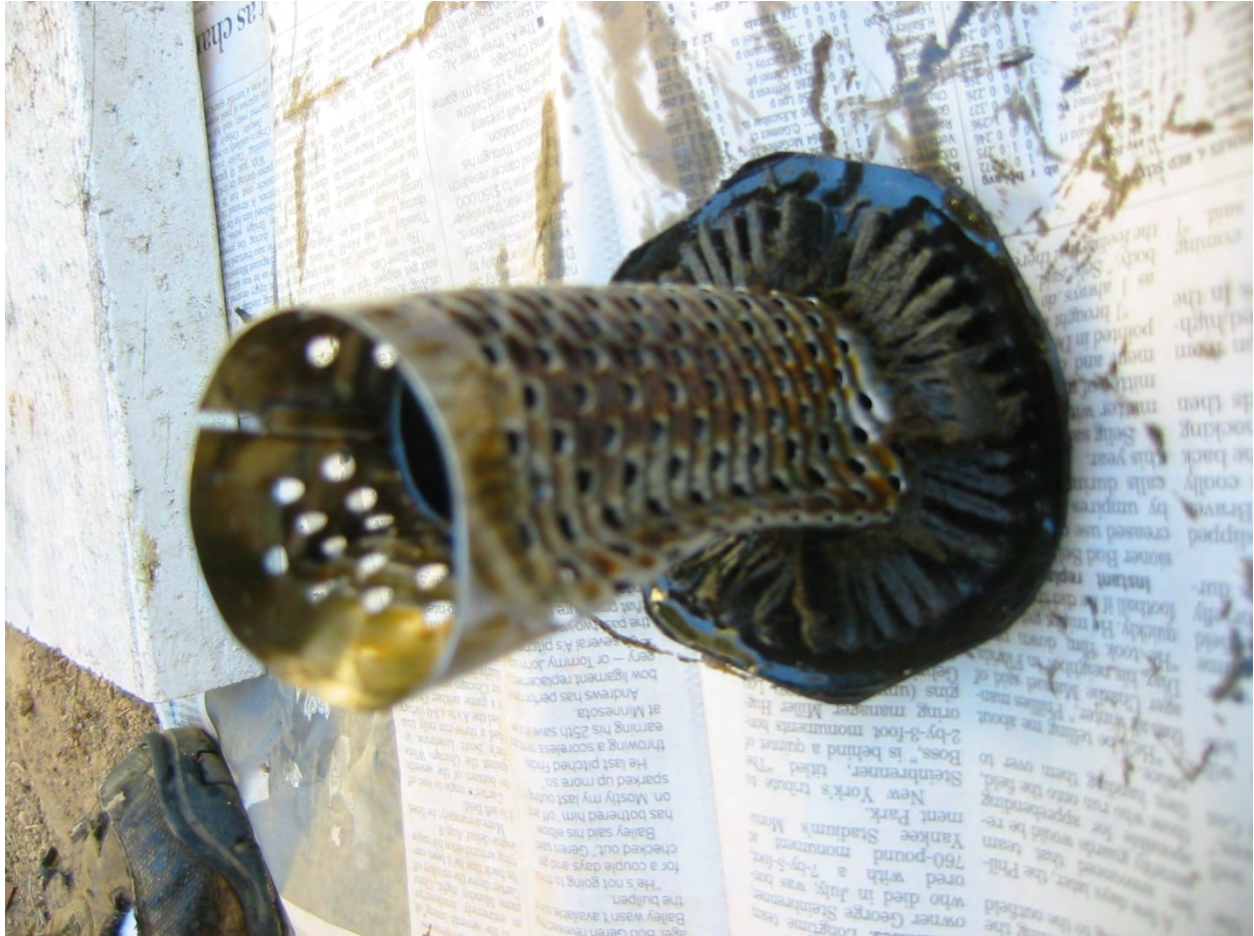
Cut apart a 2804-1 only to find for the second time the paper pleats had crushed the perforated tube:

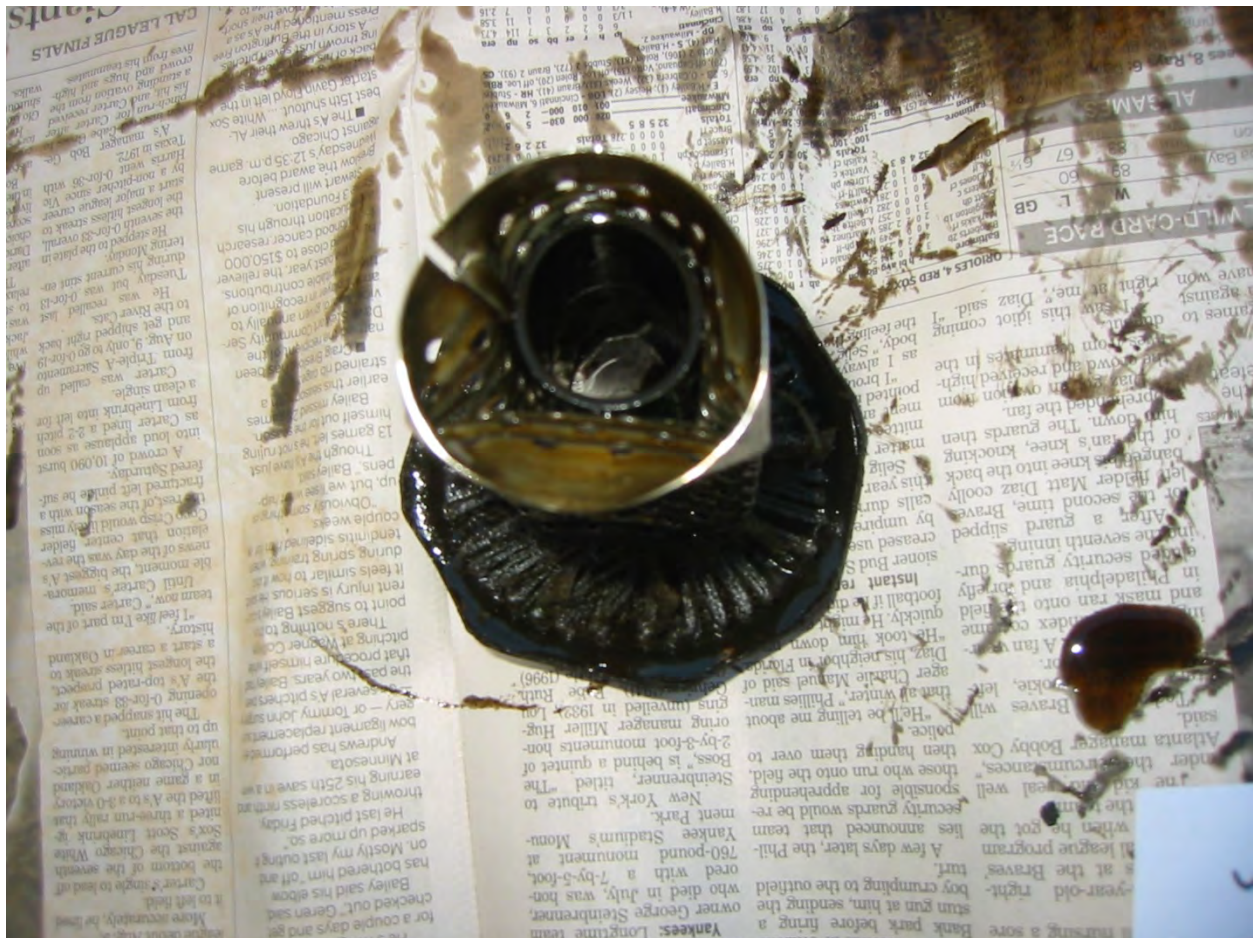
There should be an annular space between the inner standpipe and the outer perforated tube:

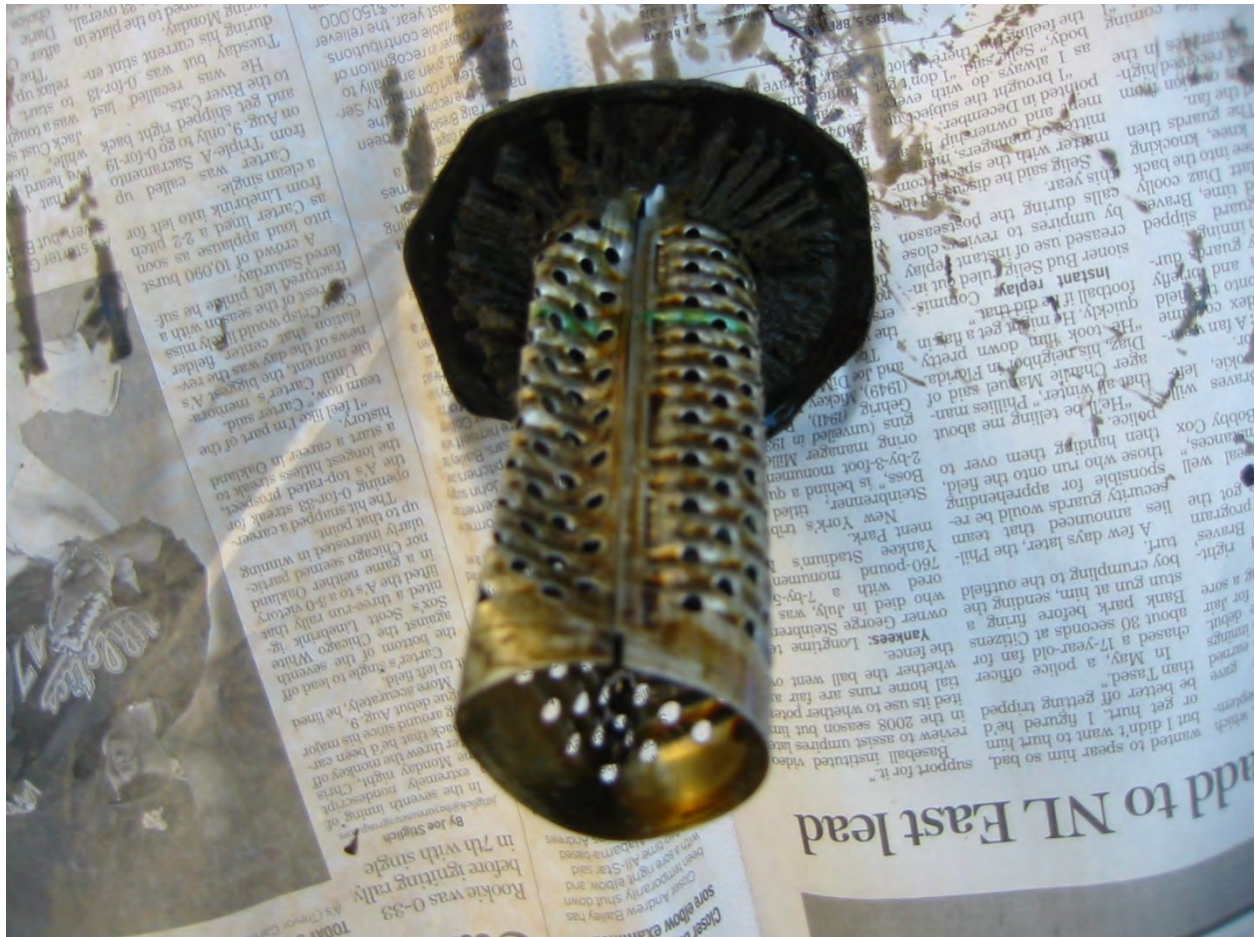
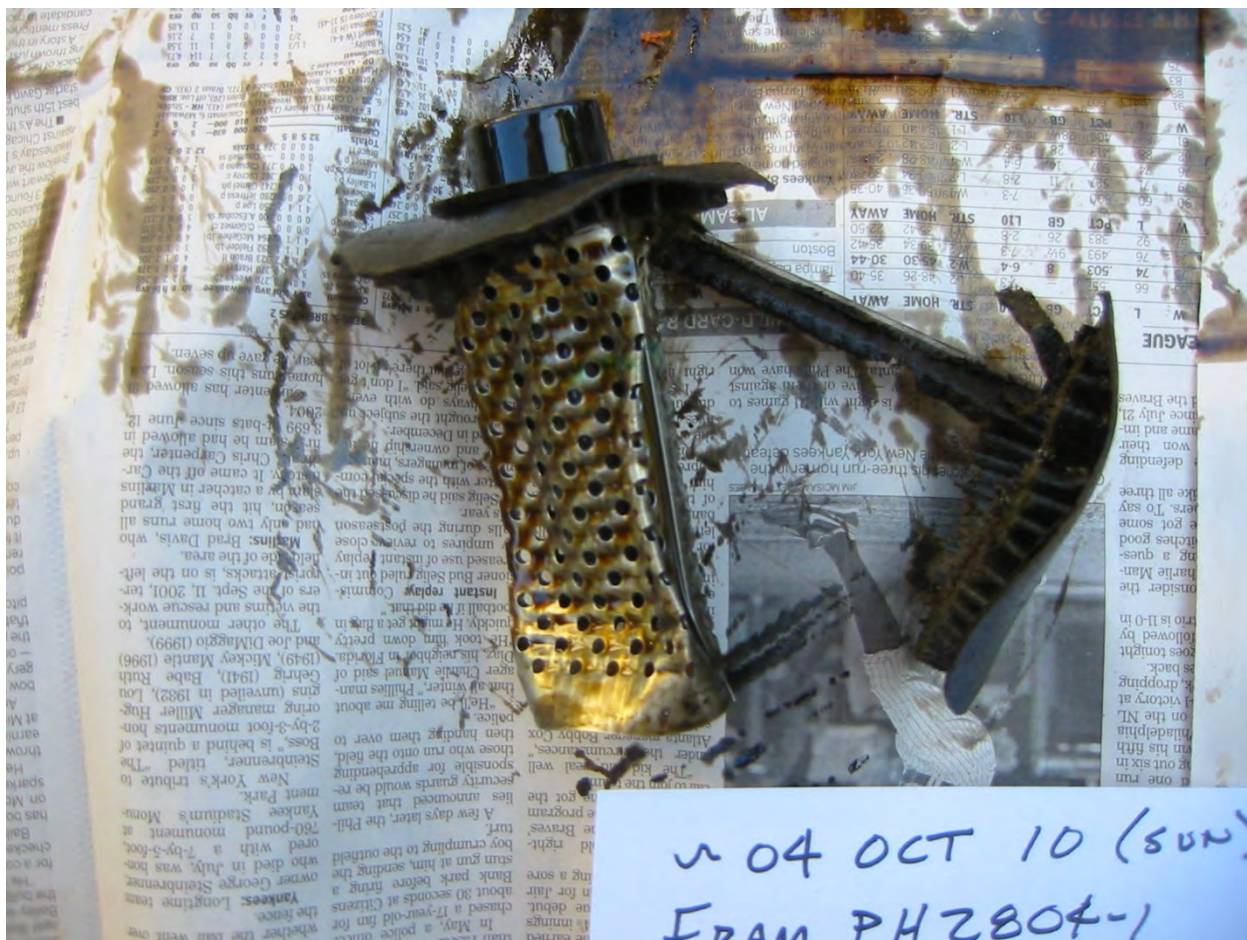
The perforated tube could not stand up to the force created by the oil flowing inward through the paper pleats:
